# BLIX CONSULTING

January 12, 2019

**Re: 2019 Danger Tree Assessment Findings at 461 Quatsino Blvd (undeveloped property)**

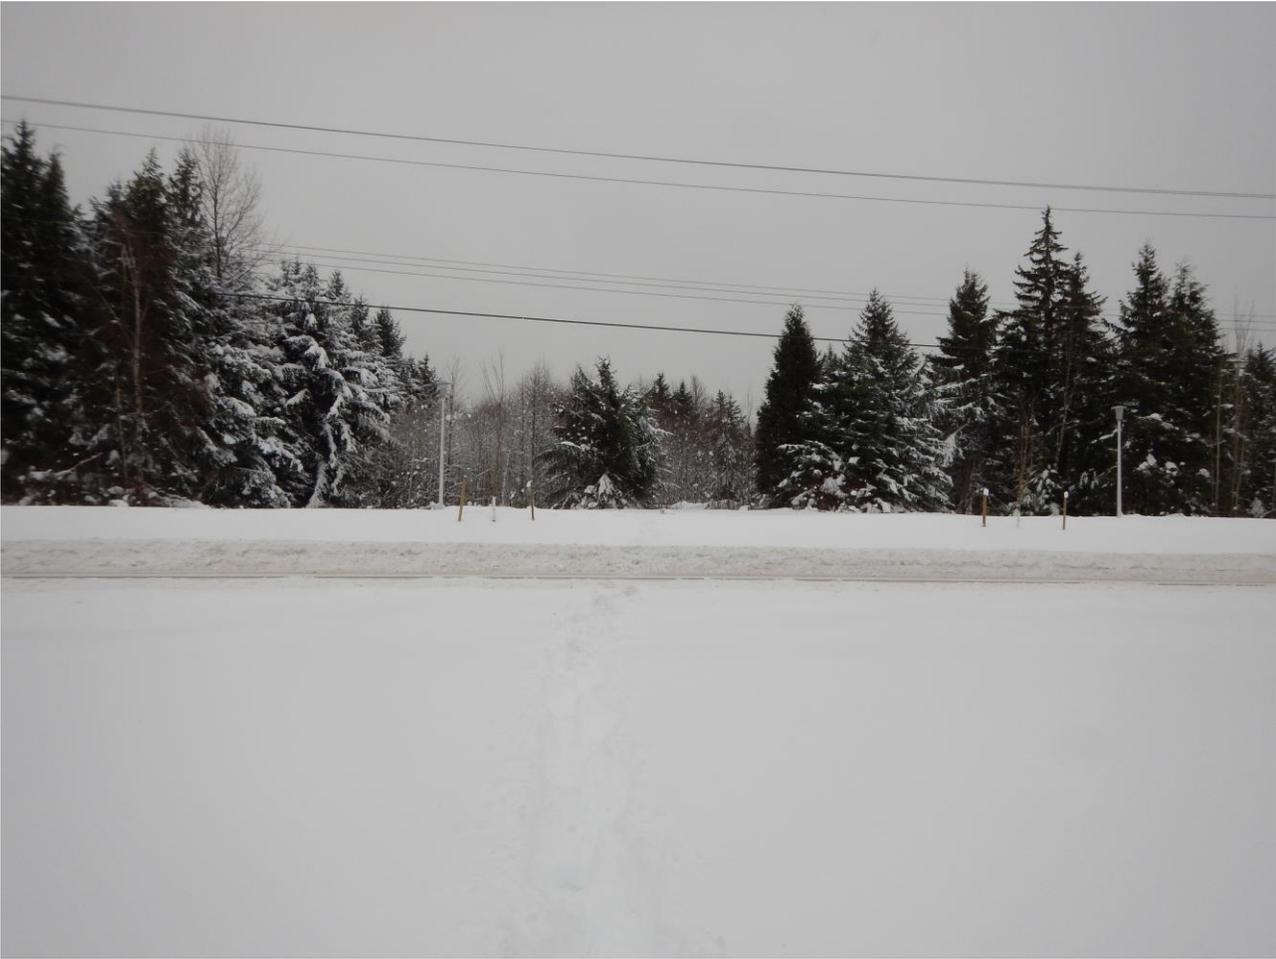
- 3) Less than 10% of the other conifers were a mix of Lodgepole Pine, Western Hemlock, and Red Cedar all which appeared to be healthy and Safe.
- 4) The tallest tree noted was a Spruce tree with a diameter of 56cm and a height of 25m. However, as noted above the majority of Spruce with similar diameters were considerably shorter and ranged between 15-20m in height.

**Photo#1:** Looking east (from appmnts on Wedeene St.) at the undeveloped property of 461 Quatsino Street. NOTE: The tallest tree on the property is a 25m tall Sitka Spruce tree (25m) located on the right side of the photo.

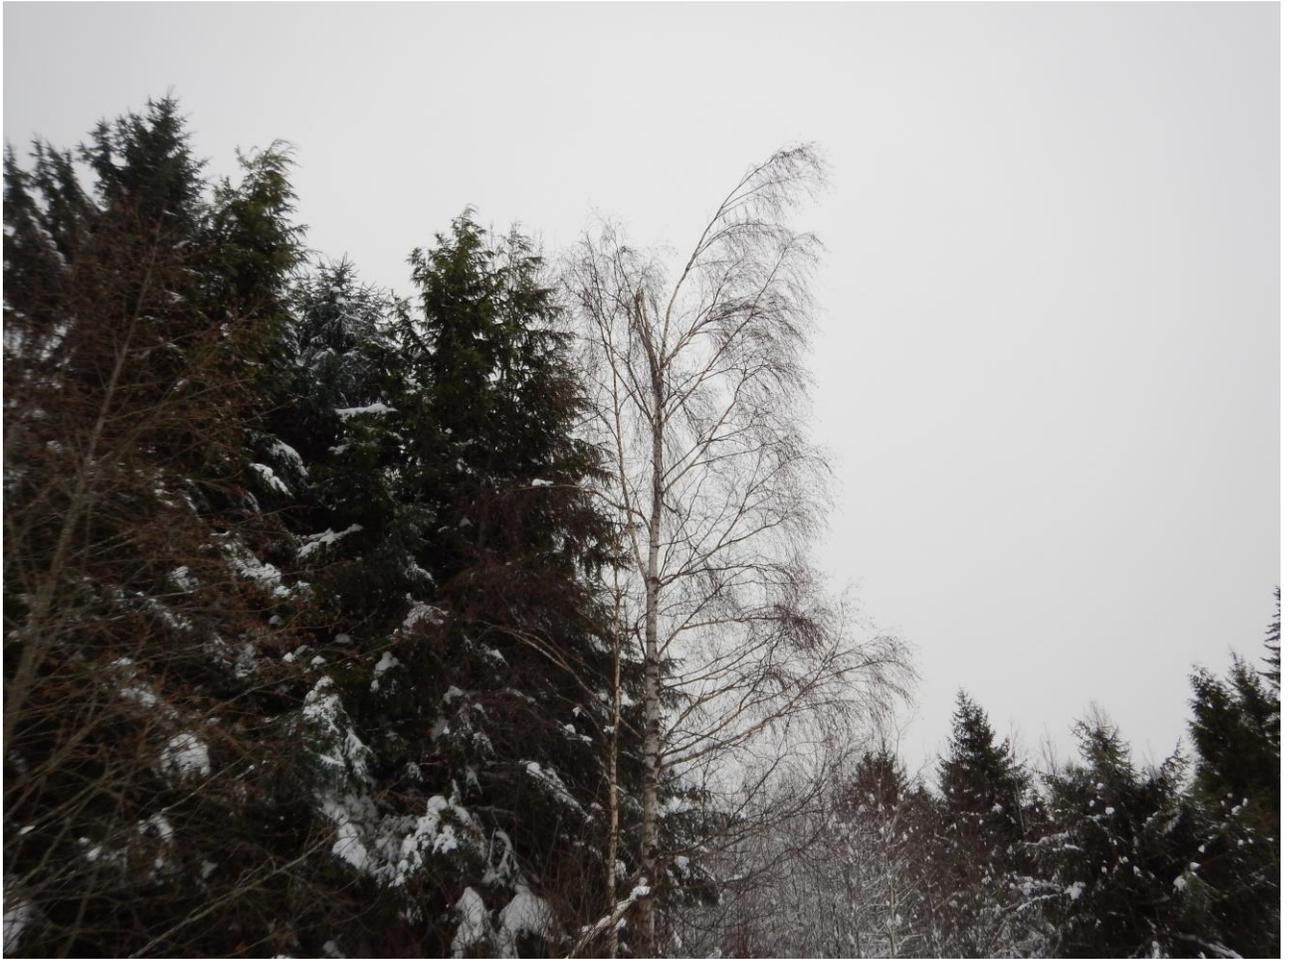
- 1) The area within the property boundary of 461 Quatsino Blvd appears to have been previous cleared... twice? Initially some 50-60 years ago which likely removed any large old growth trees (logged?) and more recently 8-10 years ago primarily down the middle of the property where smaller alders (6-10m in ht.) dominate. The fringes of both the northern and southern boundaries contain the majority of conifers that were not removed as part of the 2<sup>nd</sup> clearing thus range between 40-60 yrs. old and average 15-20m tall..... *as a result only one Danger Tree was identified; that being a 40 cm diameter Birch tree* located near the northwest corner (closest to Quatsino St.) which was noted to have a broken top and thus was marked as a ‘Danger Tree’ with both ‘Pink’ as well as ‘Orange & Black poka dot’ flagging tape (see attached photos). This tree should be removed concurrent with initial property development ideal with a piece of larger sized machinery (backhoe) or if determined safe to do so by a certified hand faller.

**Photo# 2:** The lone Danger Tree (#1) identified on the property of 461 Quatsino Blvd. A Birch Tree with a broken top.

- 1) As noted above, the 40 cm Birch Tree with a dead top and labelled as *Danger Tree #1* should be removed concurrent with initial property development ideal with a piece of larger sized machinery (backhoe) onsite or if safe to do so by a certified hand faller.

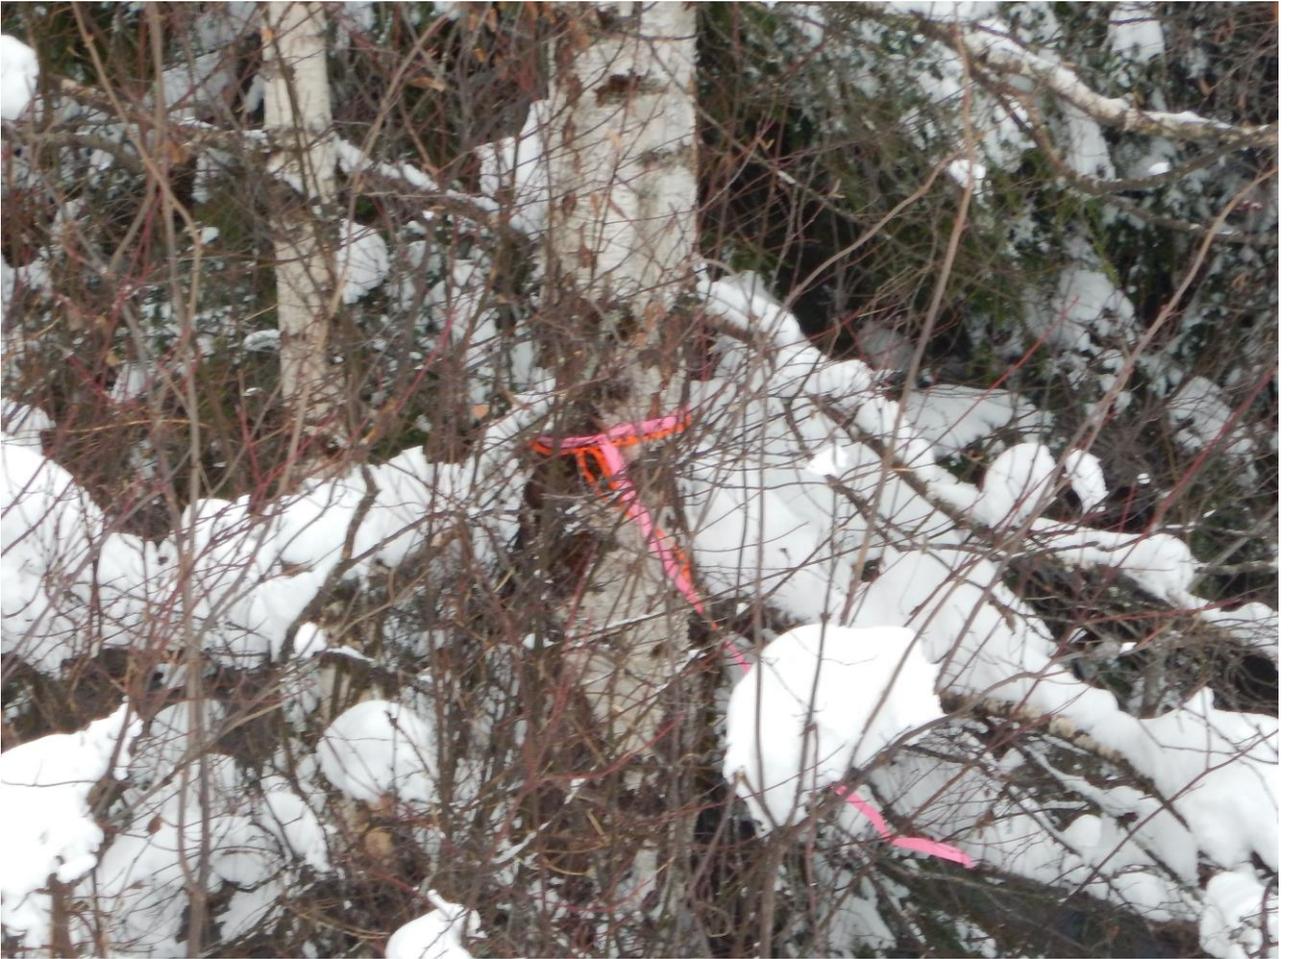
**Photo#3:** Looking at the base of the 40cm Birch Tree referred to as 'Danger Tree#1' and marked with flagging tape.

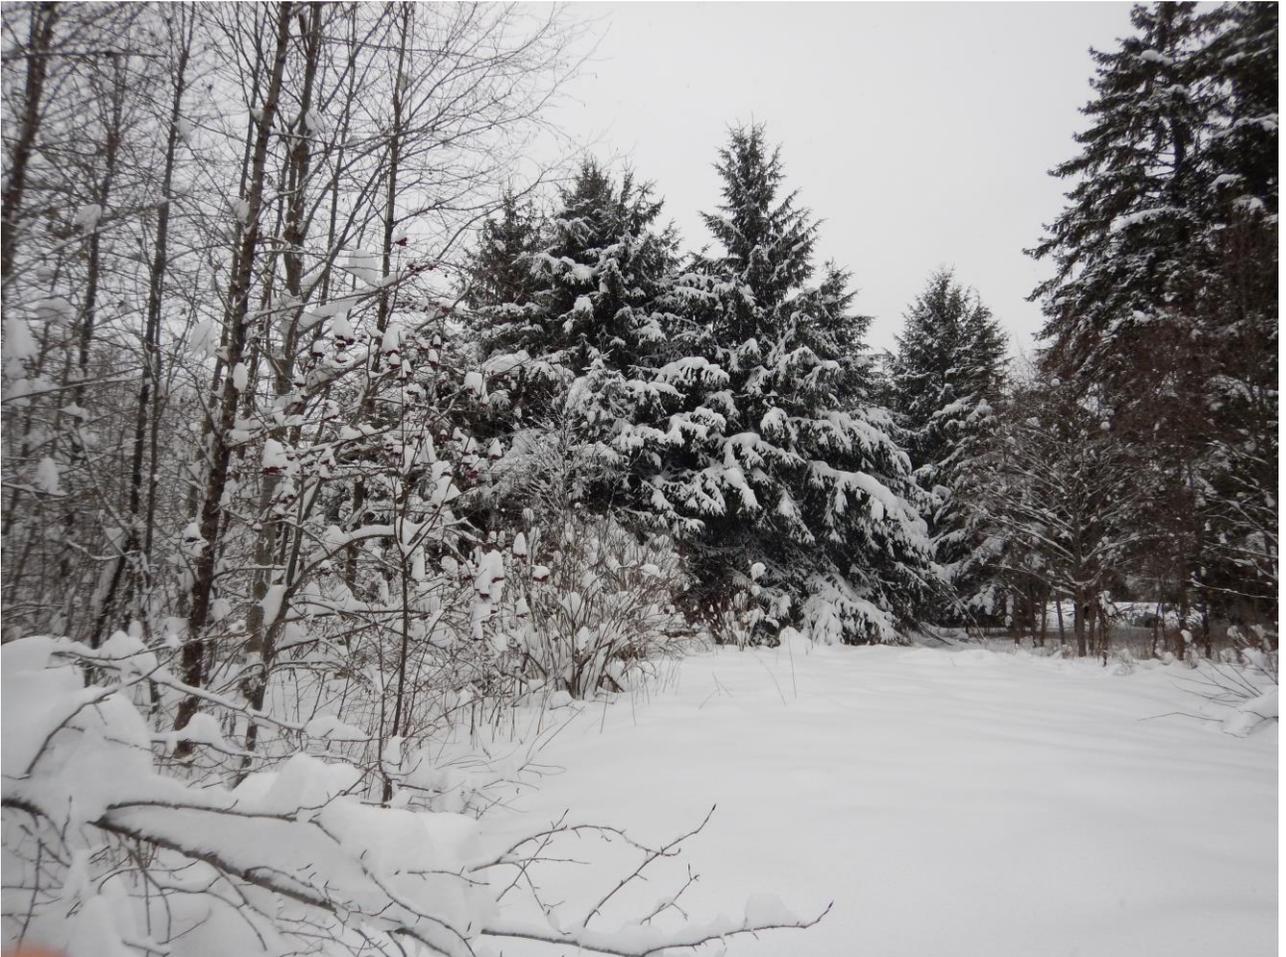
- 2) The primary coniferous tree species and notably the ‘largest’ trees on this property were identified as *Sitka Spruce* with diameters ranging from 25 to 65 cm but with heights significantly shorter than average due to excessive light and multiple tops resulting in uncharacteristically bushy/limby trees. *Notably the multiple tops on the Spruce is often associated with the Spruce Leader Weevil insect which suppresses its ability to grow in height but doesn’t kill the tree and in this case is potentially an attribute as it creates a ‘hedge like’ visual buffer that is generally very ‘wind firm’.*

**Photo#4:** Showing both the younger and smaller 8-10m tall Alder trees (primarily located down the middle of the property ) and the larger bushy Sitka Spruce most often noted down the edges of the property line and likely spared removal as part of the 2<sup>nd</sup> land clearing effort 8-10 years ago?
